PAVEMENT RESEARCH
at the
WASHINGTON STATE UNIVERSITY
TEST TRACK

EXPERIMENTAL RING NO. 3: A STUDY OF UNTREATED,
EMULSION TREATED, AND ASPHALTIC-CEMENT TREATED BASES

Report to the Washington State Department of Highways
on Research Project Y-993

Highway Research Section
College of Engineering Research Division
Washington State University
Pullman, Washington
July, 1969

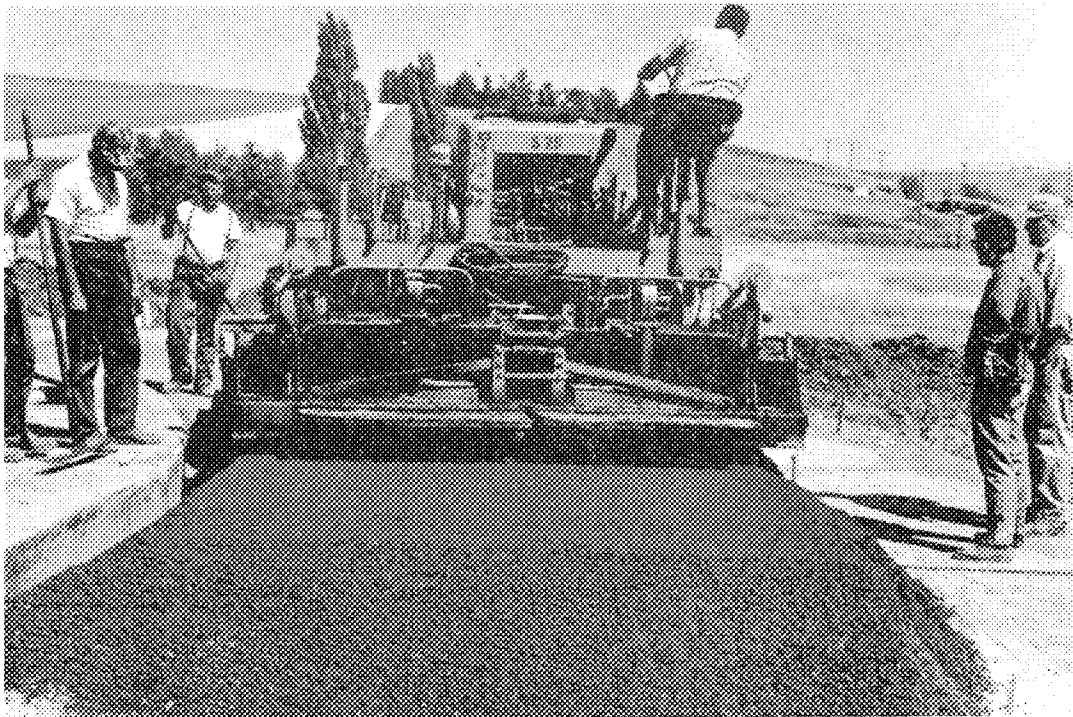
FIGURE 12. THE CRUSHED SURFACING TOP COURSE BASE IN SECTION 8 IS BEING LAID DOWN WITH A BLAW-KNOX PAVING MACHINE.

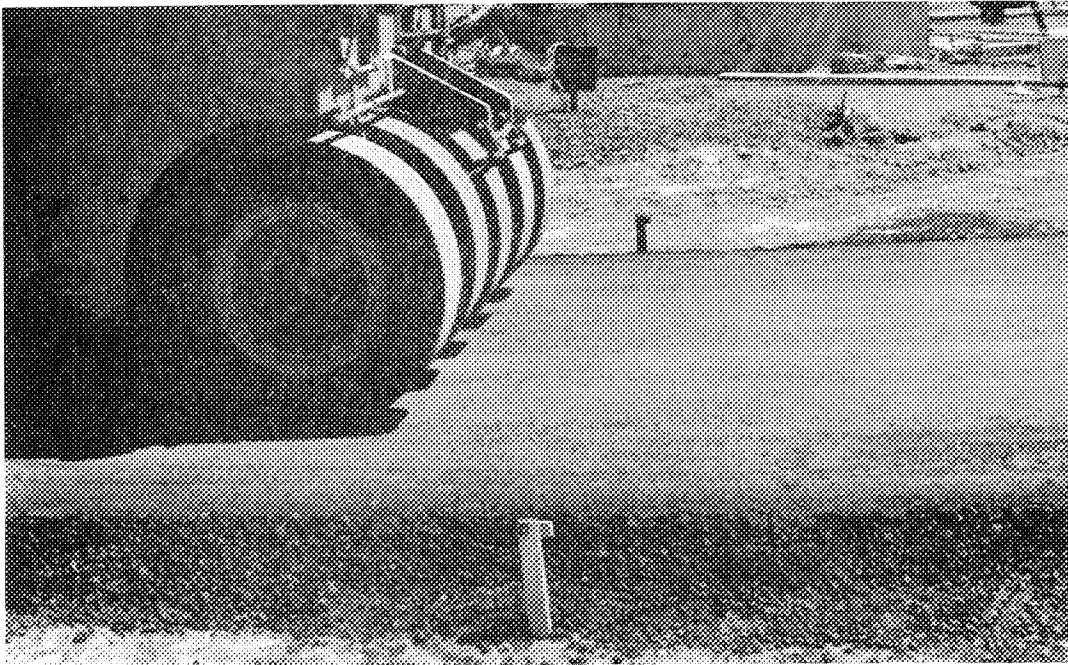
The first lift of 2-3/4" thickness was laid in Section 12. Time was 11:10 a.m., August 4. The mix looked dry. Three complete passes with the pneumatic roller were made within 2 hours as shown in Figure 13. One complete pass covers the whole 10-foot width. The relative dry density was 134 lb./cu. ft. One additional pass increased the relative dry density to 136 lb./cu. ft. No shoving or displacement of the mix was observed--except along the edges due to lack of lateral support. During the placement of the first lift rolling was delayed up to one hour to facilitate removal of excess water. Later lifts were rolled almost immediately with no adverse effects.

FIGURE 13. THE EMULSION TREATED BASE IS BEING COMPACTED WITH A PNEUMATIC RUBBER-TIRED ROLLER. NOTE THE SURFACE HAS A TIGHT COMPACTED APPEARANCE.

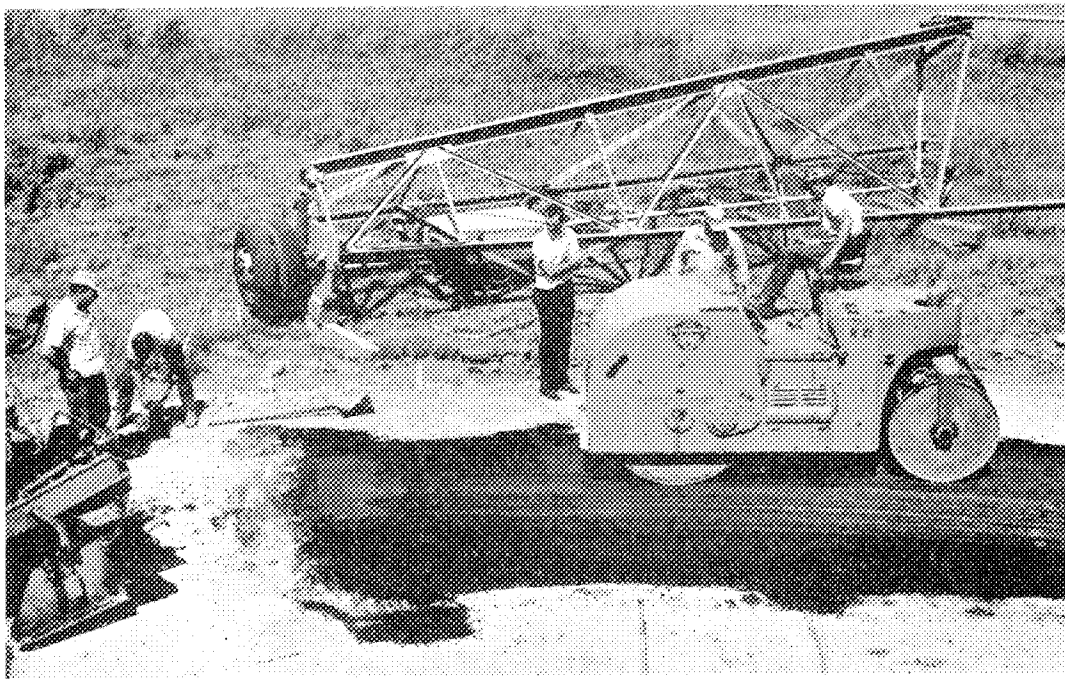
FIGURE 14. THE SPECIAL ASPHALT TREATED BASE IN SECTION 2 IS BEING COMPACTED WITH A STEEL ROLLER. NOTE THE TRANSITION ZONE FEATHERING INTO SECTION 1.

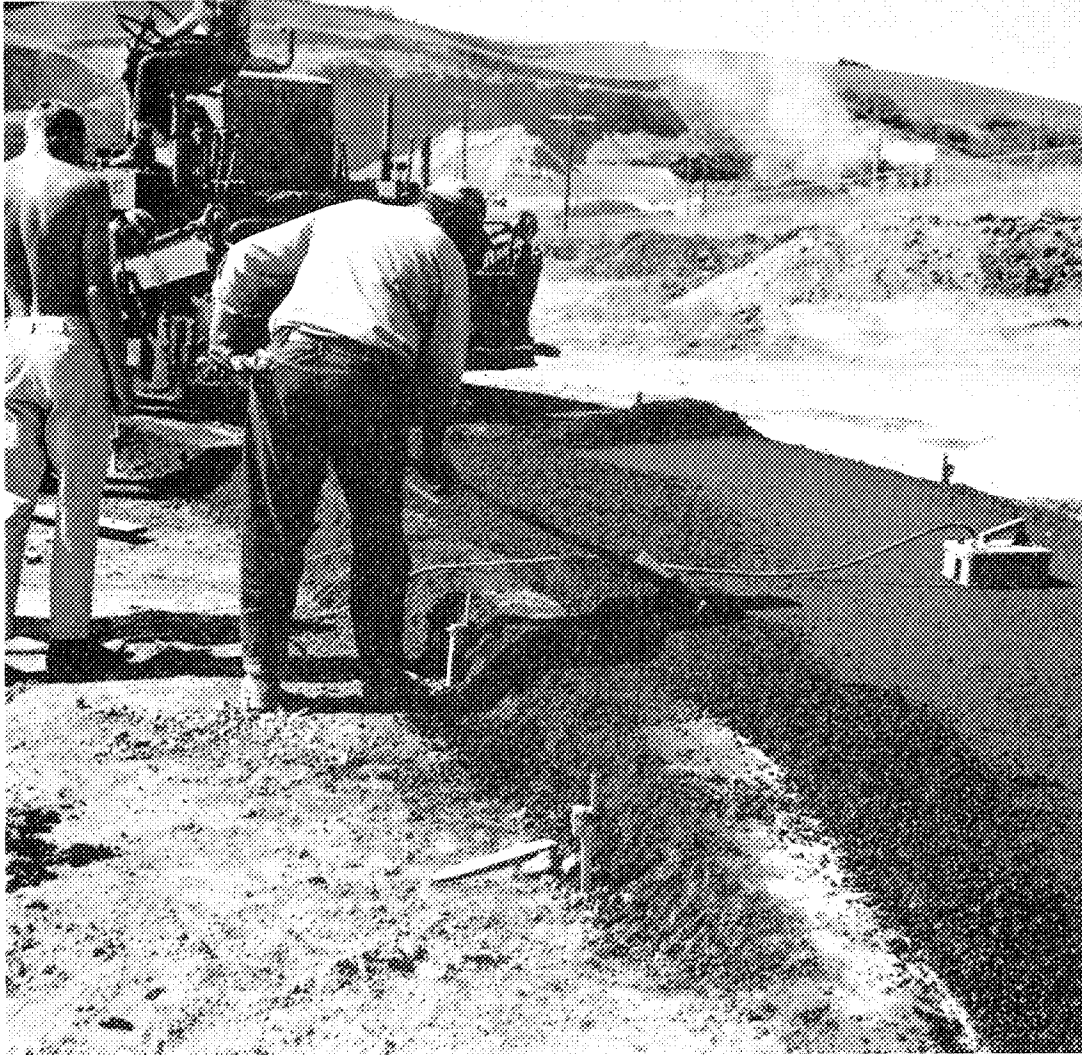
FIGURE 15. THIS SHOWS THE MEASURING OF DENSITY OF THE FIRST LIFT OF CLASS "B" ASPHALT CONCRETE WEARING COURSE IN SECTION 1. THE EDGES HAVE TO BE HAND TRIMMED DURING ROLLING TO PREVENT EDGE BREAKDOWN.

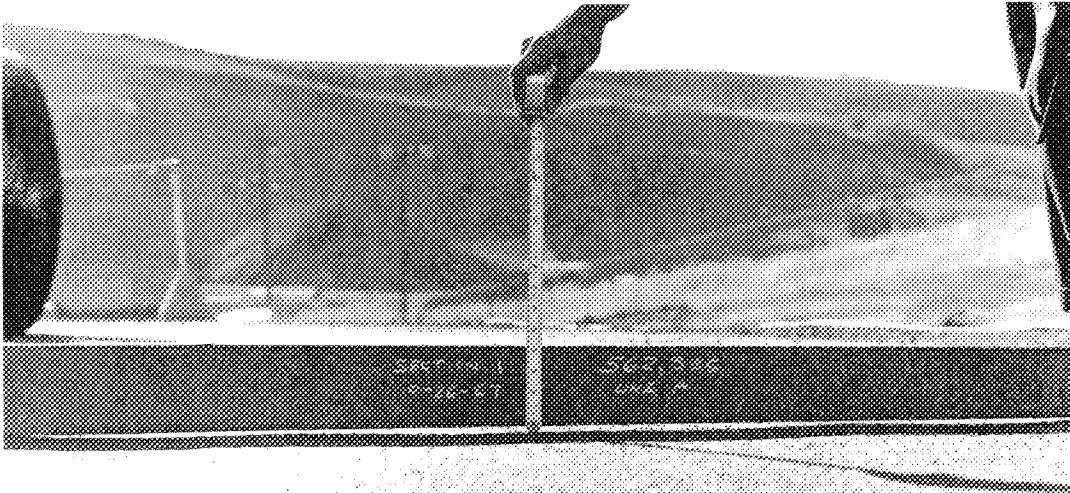
FIGURE 22. PERMANENT SETTLEMENT OF PAVEMENT IN SECTION 1 AFTER 562,335 WHEEL LOAD REPETITIONS ON LINE D-- OCTOBER 26, 1967.

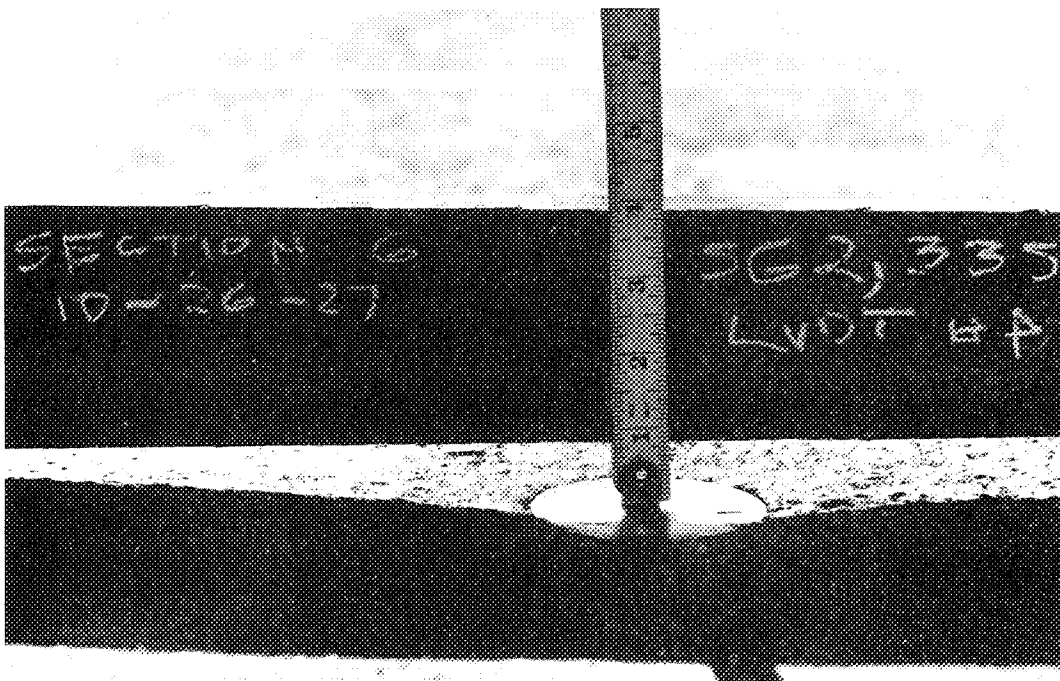
FIGURE 27. PERMANENT SETTLEMENT OF PAVEMENT IN SECTION 6 ON LINE E AFTER 562,335 WHEEL LOAD REPETITIONS, OCTOBER 26, 1967.

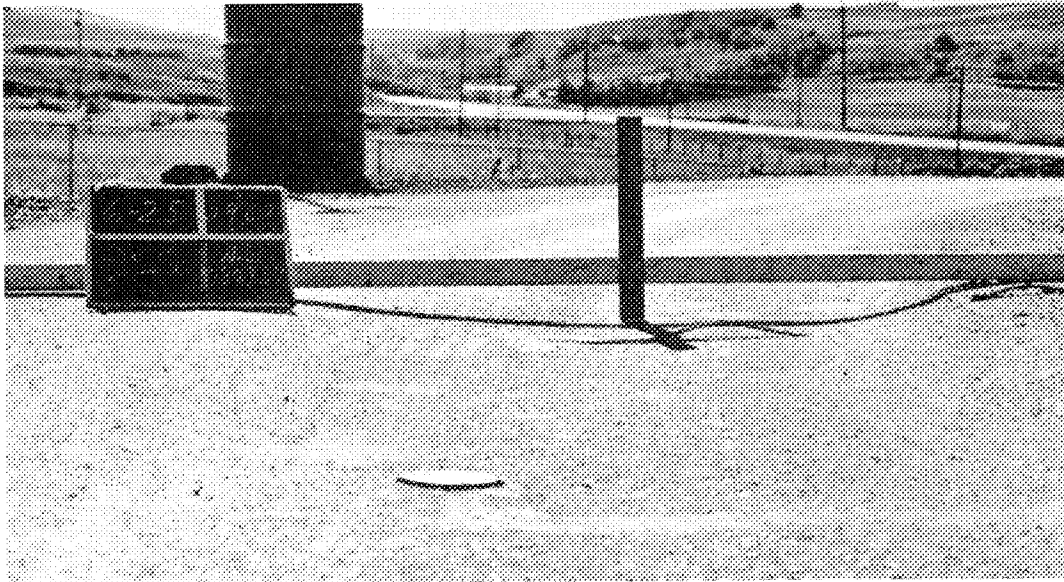
FIGURE 38. CONTINUED SETTLEMENT OF THE PAVEMENT IN SECTION 3
AFTER 780,987 WHEEL LOADS, JUNE 25, 1968.

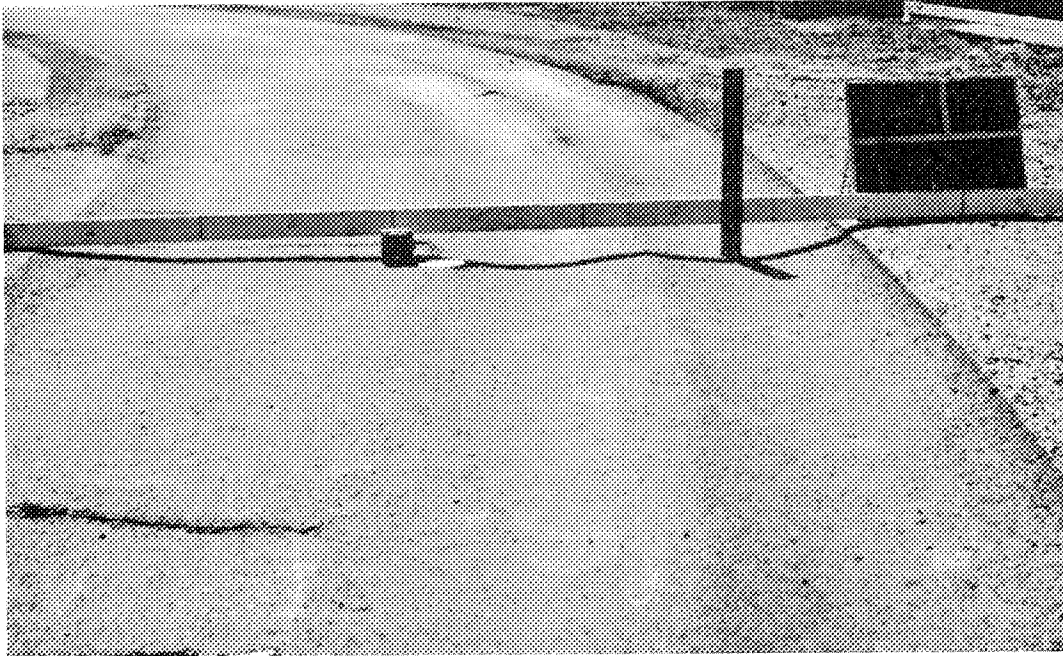
FIGURE 44. APPEARANCE OF SECTION 10 AFTER 794,763 WHEEL LOAD APPLICATIONS ON JULY 9, 1968, AND PRIOR TO PUTTING ON AN ASPHALT "SKIN" PATCH.

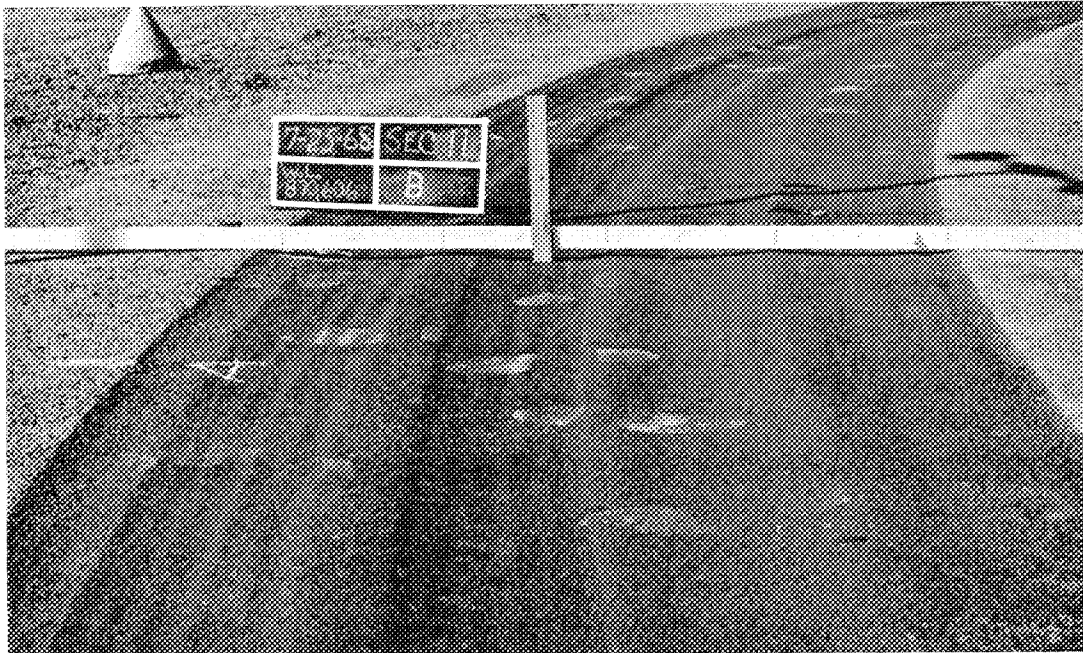
FIGURE 45. FINAL APPEARANCE OF SECTION 11 (7.0 INCHES OF ETB) ON JULY 25, 1968, AFTER 870,606 WHEEL LOAD APPLICATIONS. NOTE THE RUTTING.

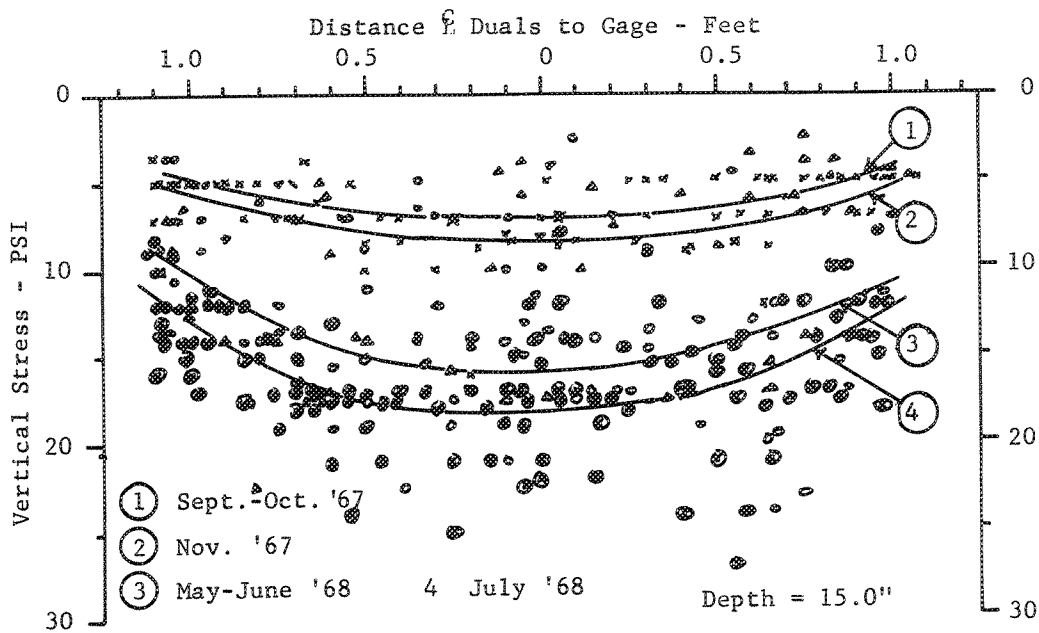
FIGURE 102: SECTION 8 - 12.0" U.T.B. P.C. A-4

Vertical stresses were measured in the 7.0- and 12.0-inch untreated crushed rock base sections 6 and 12 respectively, and are shown in Figures 101 and 102 (page 123).

The figures show that for the early fall period the 5.0 inches of crushed rock more in section 12 reduced the vertical stress at the subgrade by approximately 50%. This percentage may have increased in spring, but comparison is difficult since section 6 had failed in the fall. Figure 101 shows the different stress levels with temperature and time for section 6. Curve 1 is interesting in that it shows the stresses obtained prior to initial cracking. It is interesting that stresses increased after initial cracking and reached maximum values prior to "ultimate" failure. The reason for this phenomena may be that as the pavement system starts to break up the pavement no longer acts as a continuous slab, but now acts as a series of separate entities, which may act individually or collectively on the subgrade as pressure points thus giving higher stress values. Stresses in section 12 in the fall seem to increase slightly as the temperature fell. Some of this may be due to increased moisture in the subgrade which came from increased rainfall. In the spring, due to the saturation of the subgrade, environmental conditions and decrease in base modulus, stresses increased almost two to three times. Temperature effects decrease with depth as shown by Figures 101-104 (page 124).

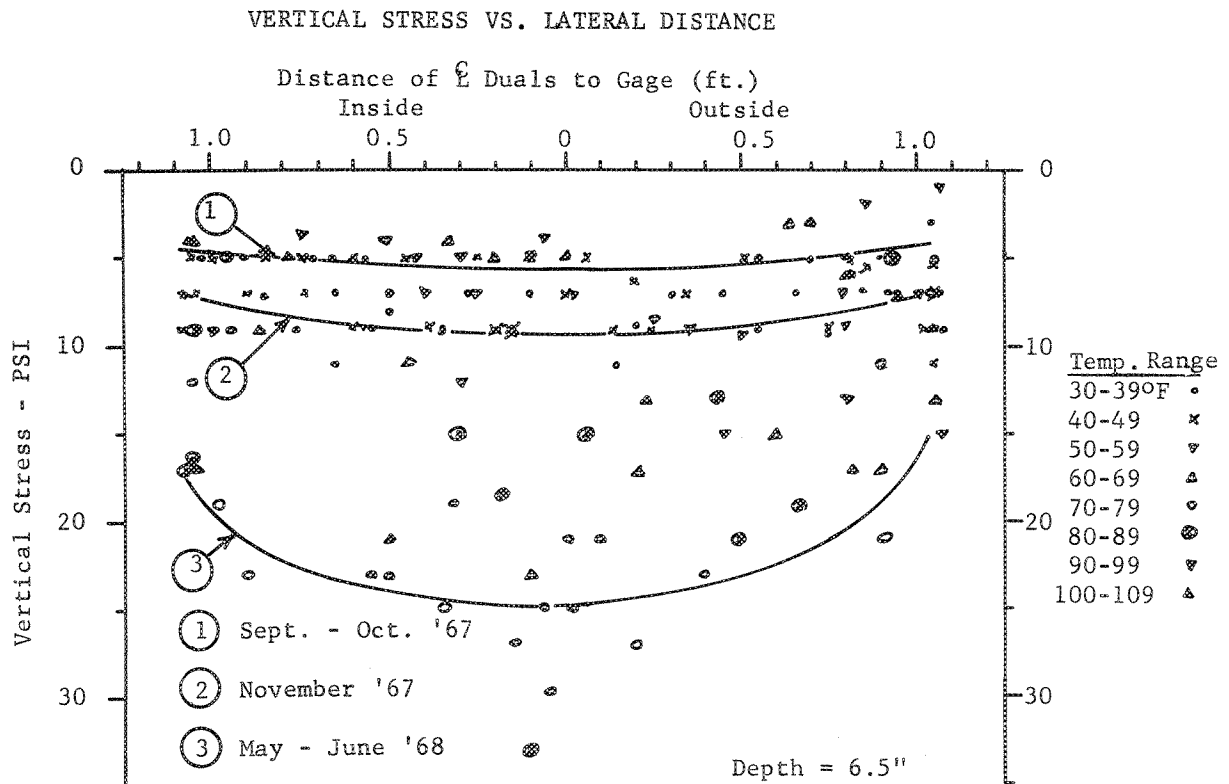
FIGURE 103. Section 3 - 3.5" A.T.B. PC A-1

In section 6, as shown in Figure 103, vertical stresses increased as temperatures decreased in the fall; this is shown by curves 1 and 2. The reasons for this may be due to increased moisture content in the subgrade and increased wheel loads. In the spring the vertical increased by more than two times. The fact that the spring vertical stresses were higher than those for the 5.0-inch E.T.B. (section 10) and shown in Figure 104 may account for the fact that section 3 failed before section 10.

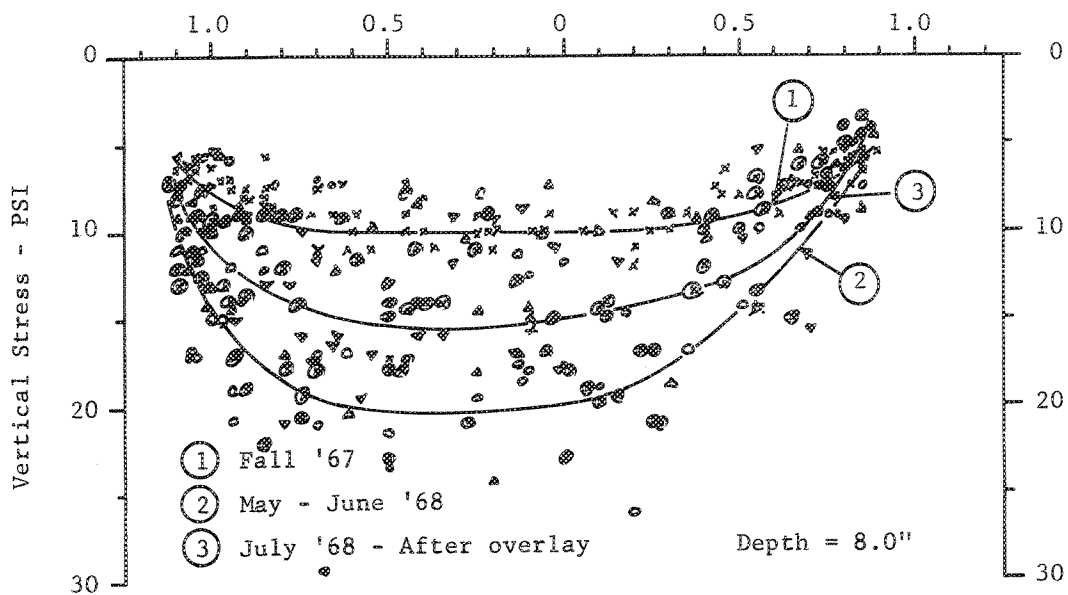
FIGURE 104. Section 10 - 5.0" E.T.B. PC A-5

Figure 104 shows the stresses obtained from section 10 for the fall and spring periods. The stresses increased in the spring by a factor of two over those measured in the fall, thus indicating that environmental conditions had affected that shear strength of the subgrade. Curve 3 shows that an asphalt overlay reduced vertical stress by some 25%.

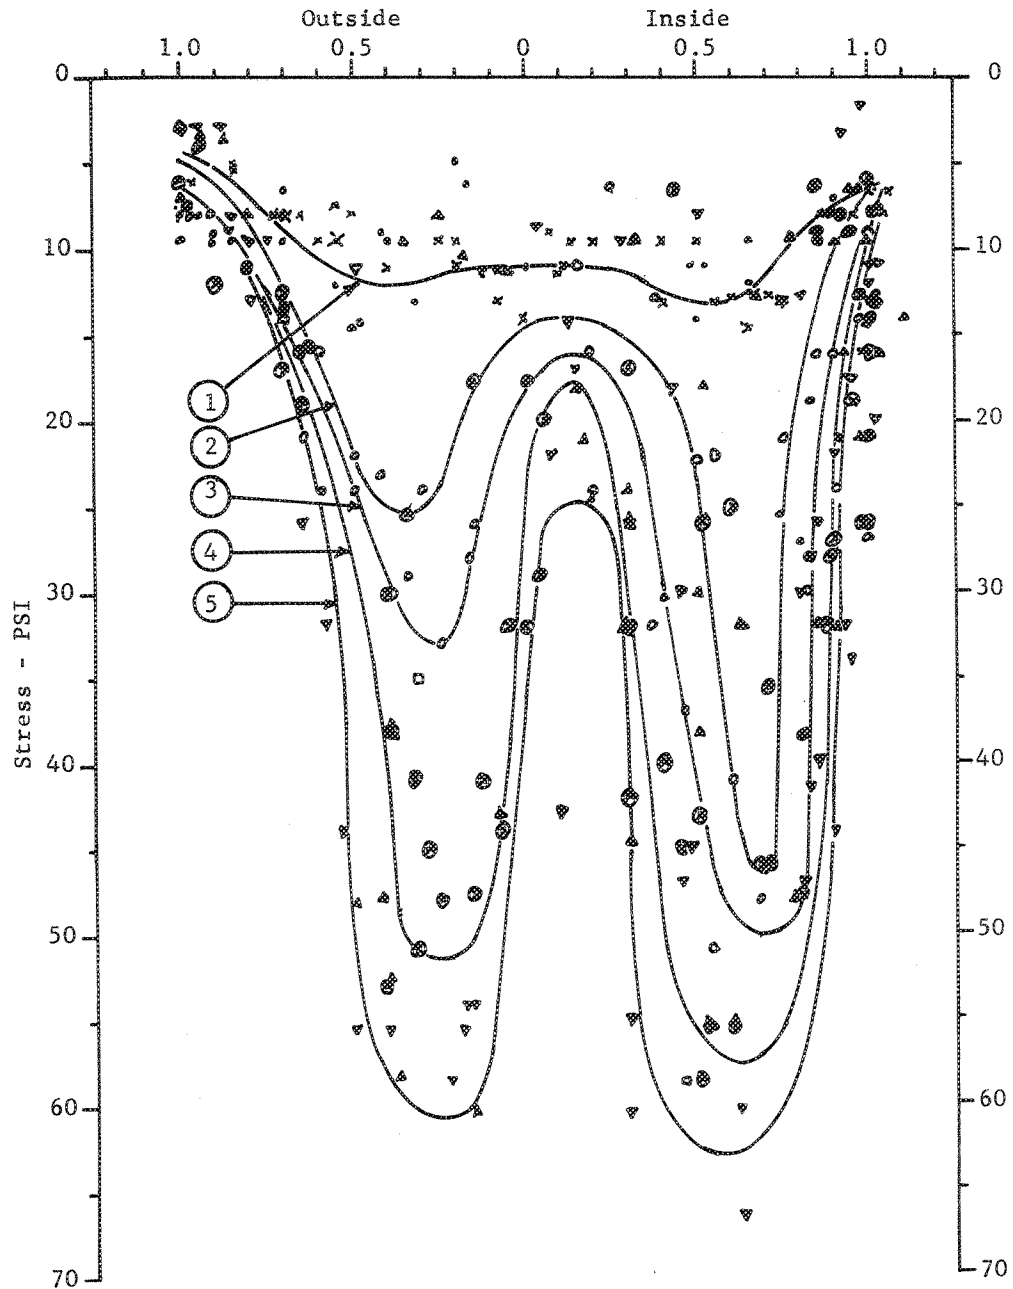
FIGURE 105: VERTICAL STRESS VS. LATERAL DISTANCE
 Ring 3 Section 12 9.0" E.T.B.
 Pressure Cell (A-2) Depth = 3.0"

Figure 105 is of interest in that it shows the effect of temperature on vertical stresses rather well. The figure also shows that the individual tires did cause higher stresses than the center of the duals. This may have been a function of the depth of the cell. Spring vertical stresses were very high and increased by over five times those measured in the fall.
